CIVIL AERONAUTICS BOARD

ACCIDENT INVESTIGATION REPORT

EASTERN AIR LINES, INC., AND AIR FORCE CIVIL AIR PATROL, OCALA, FLORIDA
NOVEMBER 27, 1951

AIR COLLISION - TAYLOR FIELD, OCALA, FLORIDA
NOVEMBER 27, 1951

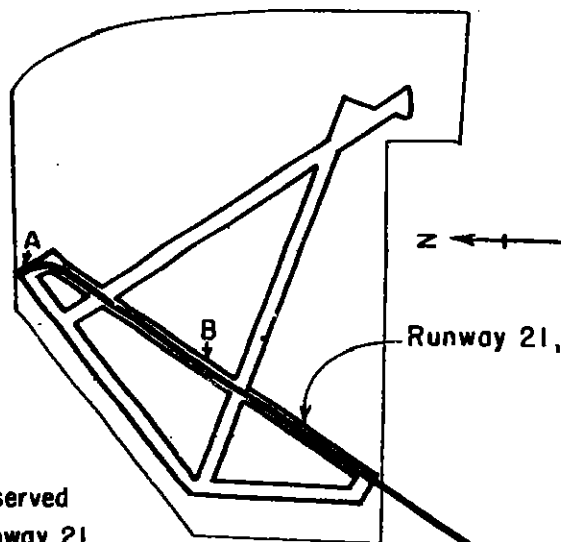
TAYLOR FIELD, OCALA, FLA.

A - Point where L4-J was observed to turn into Runway 21.

B - Point where L4-J was observed passing southwest down Runway 21.

C - Probable flight path of L4-J.

X - Approx. point of collision.

E - Approx. position where both aircraft were observed flying at approx. the same altitude and direction.

D - Probable flight path of DC-3
